# Manhole Inspection Summary

Manhole # S01EE2034MH

Insp Date: **7/21/06 6:44 AM**

**Location** Address: **6306 BENHURST RD**

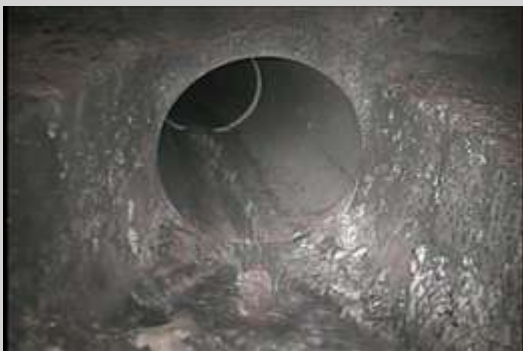
### 8 in. Circular Gravity Sewer Pipe In @ 5 O'Clock

Invert Depth: **11.30** (ft.) Flow Characteristics: **Slow**

Deposits: ☒ None ☐ Mud ☐ Sludge ☐ Debris ☐ Grease

Infiltration: **None** Pipe Seal Cond: **Unknown**

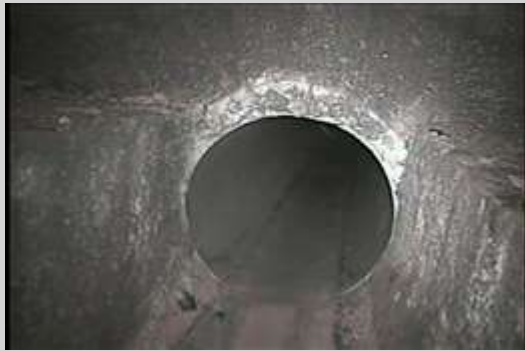
Pipe In @ 9 O'Clock

Infiltration: **None**
